When repairing a Multi-Max composite door, the repair person can choose the best of four options:

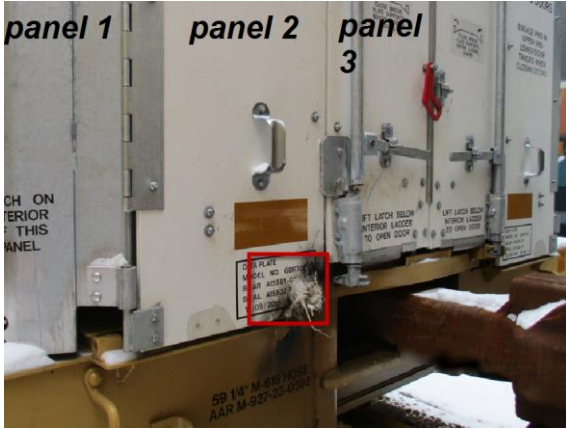
Typical repair location

- 3- APPLY COVER PLATE – This only applies to the inboard corner of panel 2, and only if the damage does not extend past existing hardware. Fabricate a tight-fitting U-shaped cover that is larger than the damaged area. Bond in place with Ashland Pliogrip (7779/300), and fasten with four 3/8 dia bolts with lock nuts.

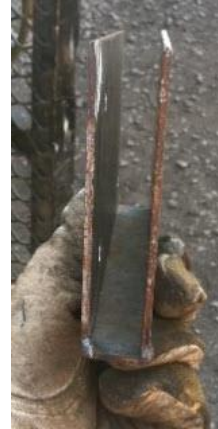
U-shaped cover plate

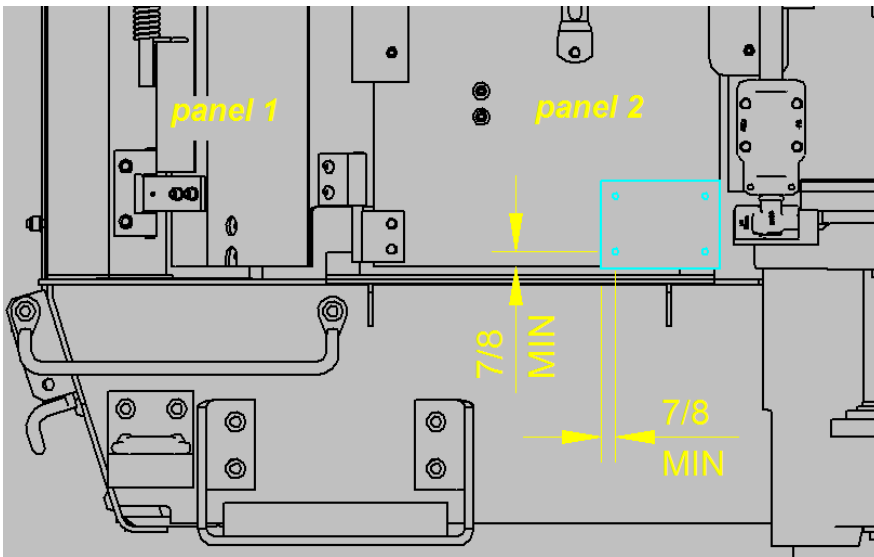
Typical repair on panel 2
