# Holden Grate-Lock® Chock Inspection and Repair Standards: Procedure and Examples

(July 2017)

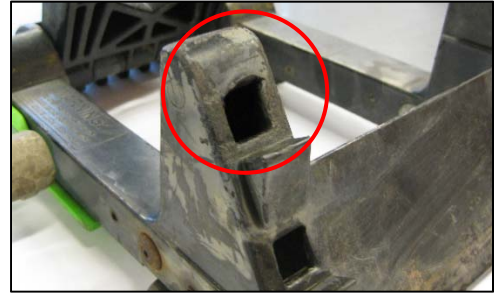
**Figure 2: Elongated Tab Engagement Holes**

- a) The tab engagement holes, found on the Base tower front faces, should be checked for cracks through member or for excessive or imbalanced elongation. Normal wear and elongation is acceptable and not a consideration for replacement, as long as both Face Plate tabs lock into place. If the holes are cracked or excessively elongated (see Figure 2), the chock is considered to be non-functional and must be replaced and sent for reconditioning.

a)	Base Tower Tab Engagement Holes	Cracked or excessively elongated	No	Send for Reconditioning	
	b)	Base Tower	Face Plate does not sit properly	No	Send for Reconditioning

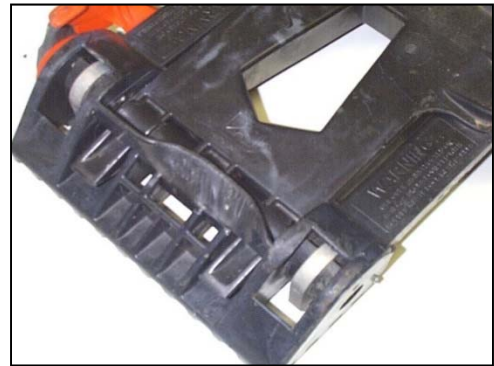
**Figure 3: Deformed Cross Web on Base**

- c) Deformation of the cross web on the top side of the chock Base or strain whitening marks found in the corners of the cross web indicate a weakened structural component. (See Figure 3). However, in both cases, the chock is still considered to be functional and does not need to be replaced.

c)	Base Cross Web	Strain whitening marks in corners or visible deformation	Yes	Use as is	
	d)	Strut Side Restraint Paddle	Deformed, bent or cracked near main body	Yes	Use as is	
			Broken or excessively bent	No	Send for Reconditioning

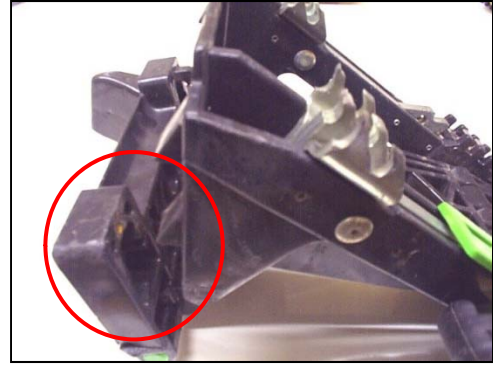
**Figure 4: Missing Face Plate Tabs**

- e) The Face Plate tabs should be checked to ensure that they are neither missing (see Figure 4), nor bent, nor cracked where they meet the Face Plate. In the latter case, the chock may still appear to be fully functional. However, in all cases the chock is considered to be non-functional and must be replaced and sent for reconditioning.

e)	Face Plate Tabs	Missing, deformed or hairline crack	No	Send for Reconditioning	
	f)	Cam Shaft Operating Handle	Broken	No	Send for Reconditioning	
			Rotates without any resistance	No	Send for Reconditioning

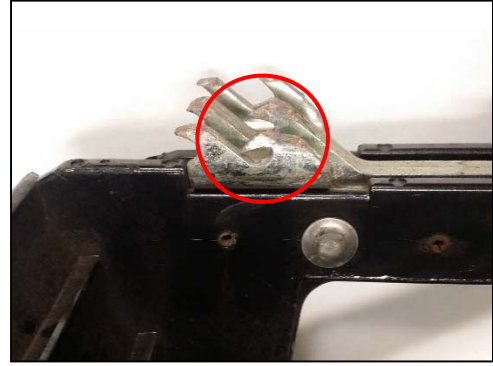
**Figure 7: Bent Adjacent Tooth Tips**

- a) Verify that the left, the right, and the center Steel Teeth Plates are all present and not damaged. If any Steel Teeth Plate is missing or any adjacent Tooth tips are bent (see Figure 7), the chock is considered to be non-functional and must be replaced. If a single steel tooth is bent, straighten accordingly. This repair can be performed in the field. Minor wear and normal rusting is not a reason to replace the chock.

C. Underside Components	a)	Steel Teeth Plates	Missing plates or adjacent tooth tips bent	No	Send for Reconditioning	
			Single tooth tip bent	No	Repair in the Field	Grip the tooth firmly with pliers and bend it back into alignment.
	b)	Grating Latch Teeth	Deformed or broken	No	Send for Reconditioning	
	c)	Base Cleats	Three adjacent or more than five cleats over waffle area broken or missing	No	Send for Reconditioning	
			Two pairs of adjacent cleats or a total of five cleats over waffle area broken or missing	No	Repair in the Field	Grip the cleat firmly with pliers and bend away from the Base until it breaks off. Use a file to remove any residual shards.

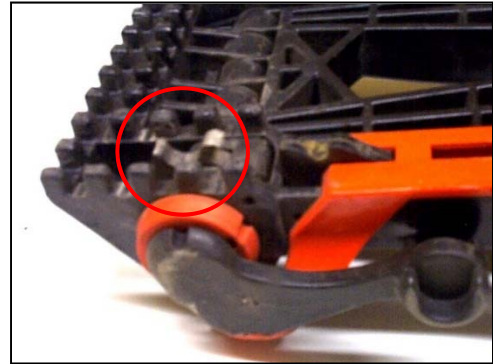
**Figure 8: Broken Grating Latch Teeth**

- b) The Grating Latch teeth must be checked for distortion or elongation. If either tooth is deformed or broken off (see Figure 8), the chock is considered to be non-functional and must be replaced and sent for reconditioning.

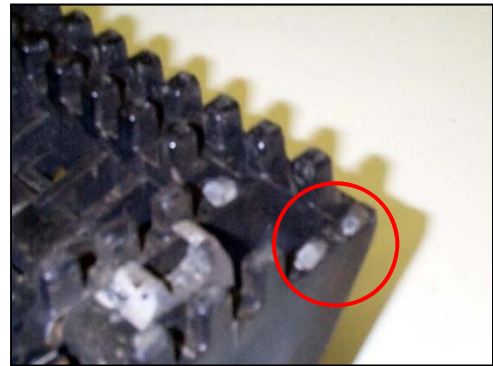
**Figure 9: Missing Cleats on Waffle Area**

- c) All the cleats in the “waffle area” found on the chock underside should be straight. If three adjacent cleats or more than five cleats over the entire waffle area are missing (see Figure 9), the chock is considered to be non-functional and must be replaced and sent for reconditioning.
