Vehicle Restraint System Field Repair Manual

November 2011 Revision A

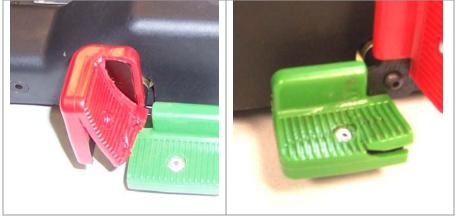
Description	Quantity	
Left pedal assembly Lock pedal, Part No. 7052-16 (Qty: 1) Pedal cover red, Part No. 7052-28-LH (Qty: 1) Pedal cover green, Part No. 7052-29-LH (Qty: 1) 3/16 X 1/2 Pop rivet (Qty: 2)	1	
M5 X 0.8-12 Button head screw	1	9
M5 Flat washer	1	0

- Rubber pedal becomes torn
- Metal lock pedal becomes severely deformed
- Pedal detaches
- Pedal is missing

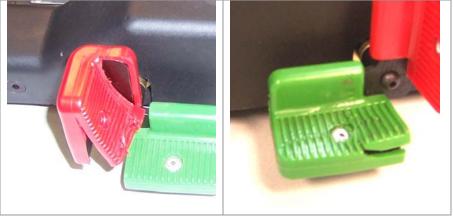
Description	Quantity	
Right pedal assembly Lock pedal, Part No. 7052-16 (Qty: 1) Pedal cover red, Part No. 7052-28-RH (Qty: 1) Pedal cover green, Part No. 7052-29-RH (Qty: 1) 3/16 X 1/2 Pop rivet (Qty: 2)	1	
M5 X 0.8-12 Button head screw	1	0
M5 Flat washer	1	0

- Rubber pedal becomes torn
- Metal lock pedal becomes severely deformed
- Pedal detaches
- Pedal is missing
