# Crashworthiness and Puncture Protection Analyses of LNG Tenders

## Final Report

March 2019

### **Applied Research Associates, Inc.**

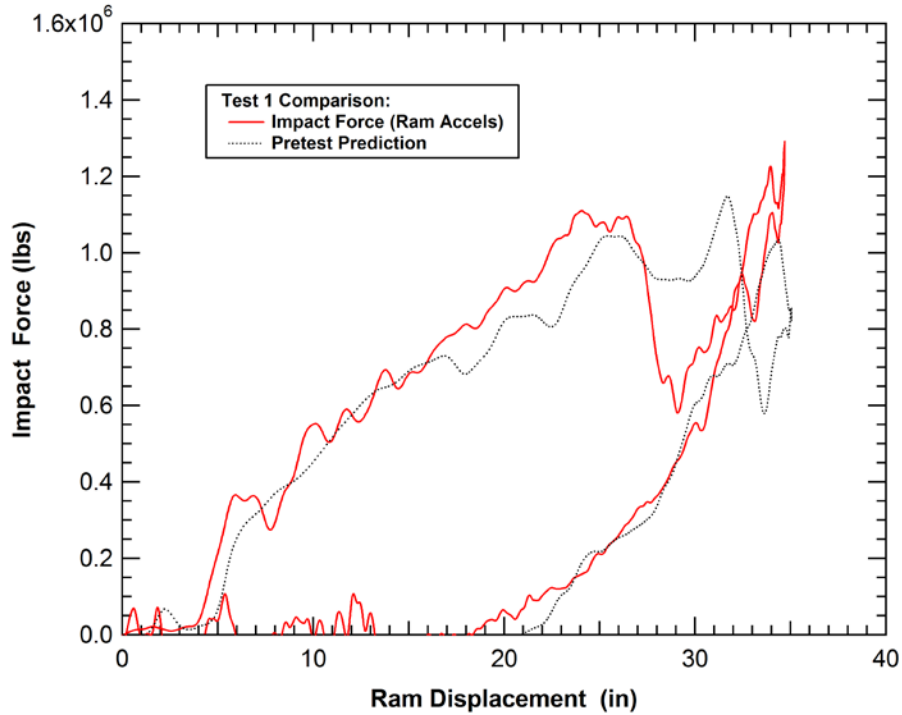
Figure 3. Comparison of the measured and predicted Test 1 force-deflection curves.

The tests were fully instrumented with accelerometers, string potentiometers, pressure gauges, and strain gauges. These measurements were compared to the model predictions to validate the model. Overall, very good agreement was obtained between the prediction and test for the various measurements made. An example of the agreement is the comparison of the predicted and measured force-deflection curves, shown in Figure 3. This force-deflection curve is an important characteristic of the tank car for a given impact scenario. The area under the force-deflection curve is the impact energy that is dissipated (the primary measure used to assess the puncture protection levels). The comparison of the force-deflection behaviors shows good agreement between the calculation and the test.

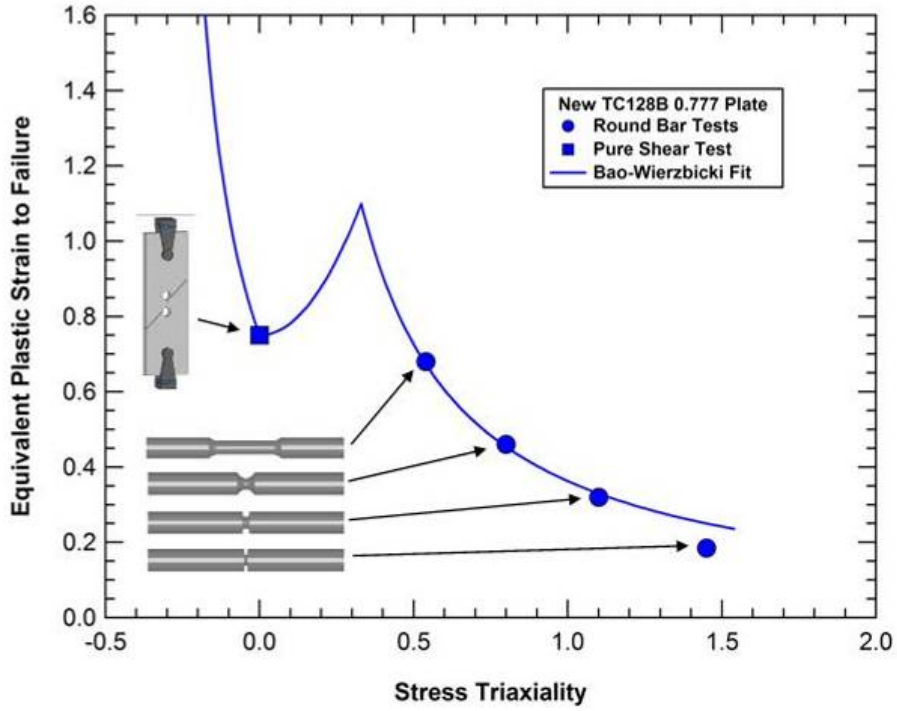
Figure 4. Bao-Wierzbicki failure surface and tests used for model calibration.

The material damage and failure model applied is the Bao-Wierzbicki (BW) model [62, 63] that defines the material damage development based on the current stress state in the material and the plastic strain increments. The critical strain function is that proposed in the BW criterion and contains multiple branches depending on the range of stress state, as shown in Figure 4. The critical strain in each branch are governed by the equation

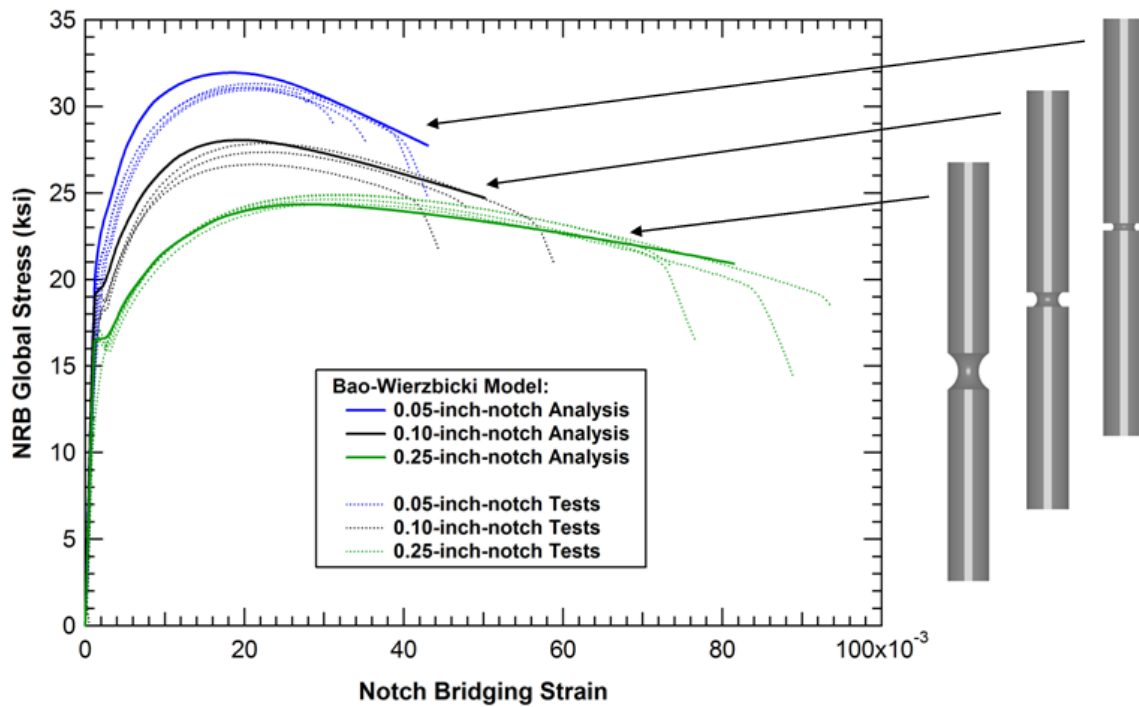
Figure 5. Validation of the notched round bar test behavior for TC128B.

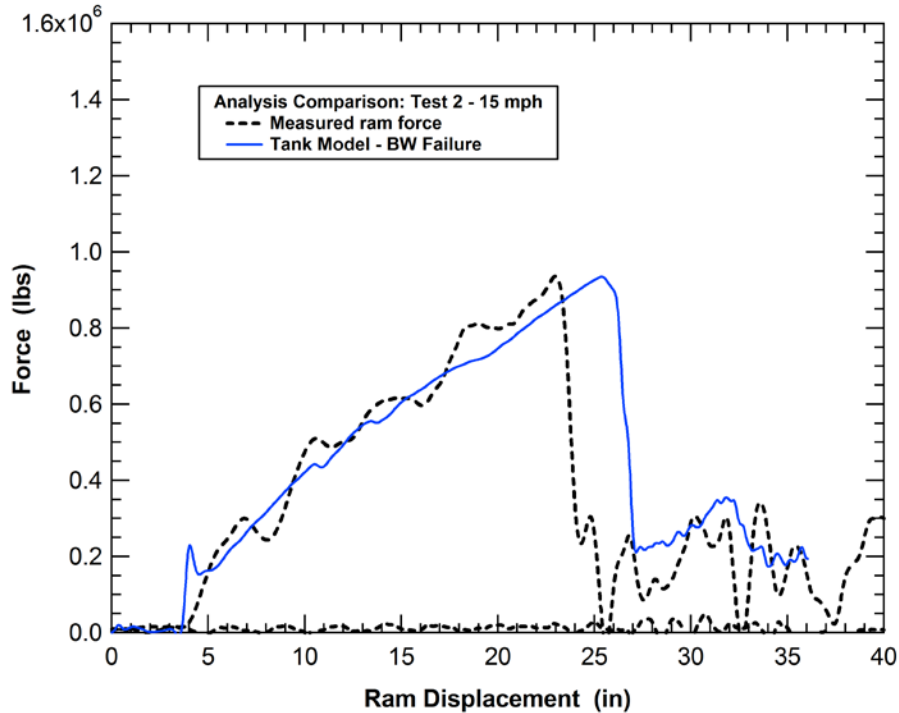
Figure 9. Tank puncture analysis of Test 2 with Bao-Wierzbicki failure assessment

The comparison of the measured and calculated force-deflection behavior for Test 2 with the tank puncture model is provided in Figure 9. The comparison shows overall good agreement between the calculation and test. The peak load at which the tank was punctured was very accurately captured by the model. The measured puncture force was 940,000 lbs and the calculated puncture force was 915,000 lbs. The primary discrepancy of the test and model was a slightly more compliant behavior in the model seen at the large displacements. This difference in compliance could primarily be attributed to the removal of the manway from the tank model in this analysis.

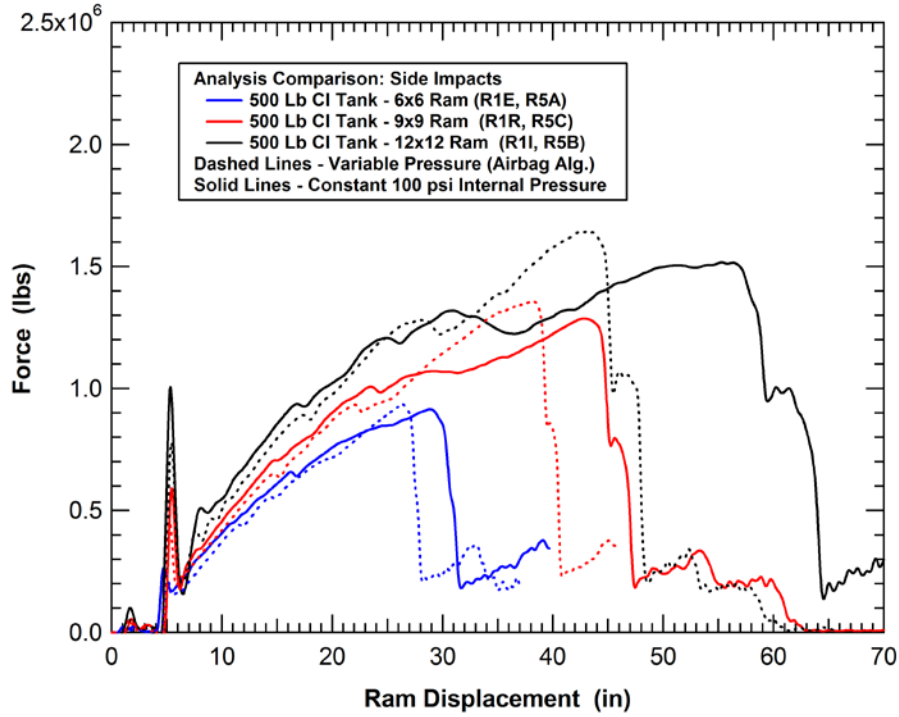
Figure 11. Effect of variable internal pressure on 500 lb tank impact response.

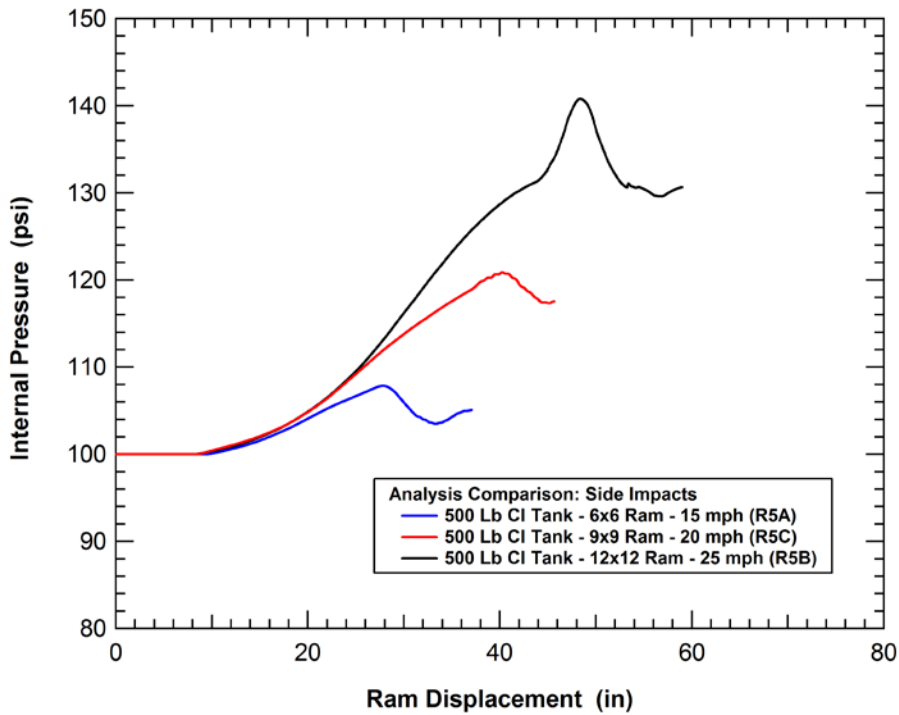
Figure 12. Calculated internal pressure variations in the 500 lb tank impact analyses.

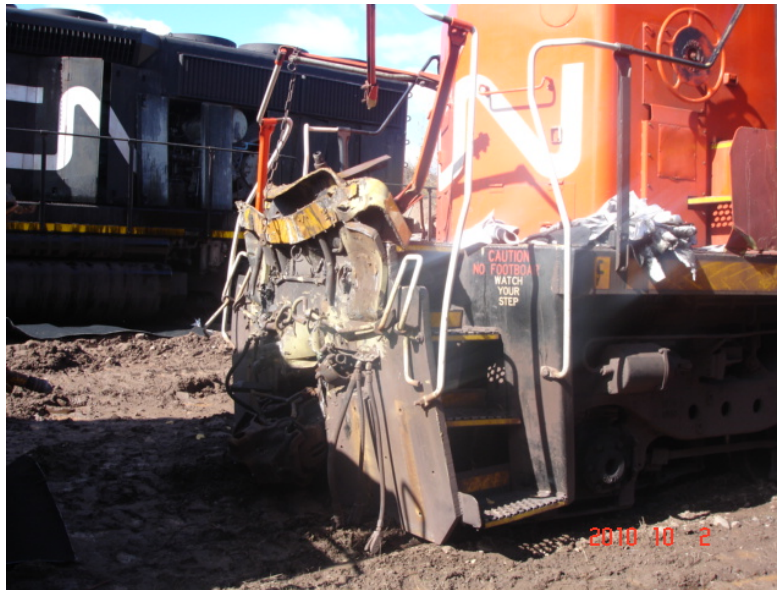
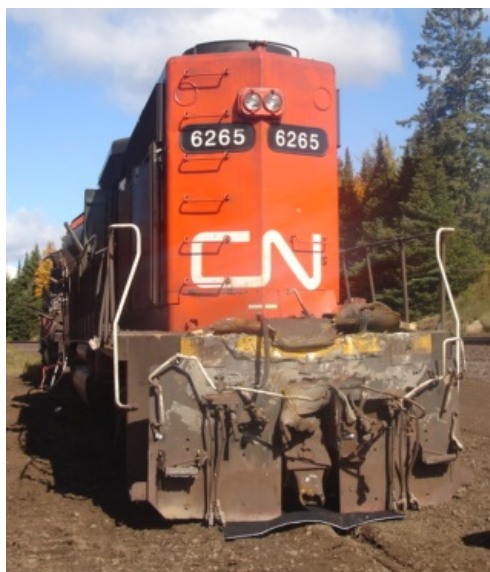
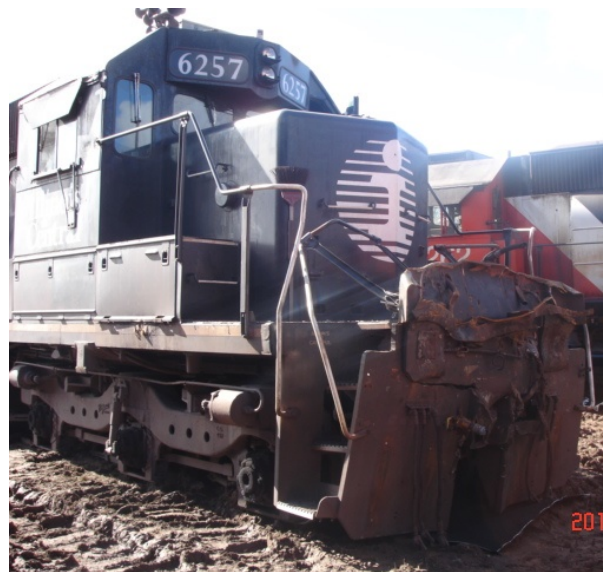
(a) Damage at the leading locomotive end.

(b) Damage at the NB L1-L2 interface.

Figure 32. Photographs of locomotive damage in the Two Harbors collision scenario.

These collision behaviors are consistent with those observed in the Two Harbors collision as seen in Figure 32. Wherever possible, we are working to validate the FE analyses with the observable damage seen in the two harbors collision. The combination of matching the observed response and the agreement between the FE and lumped mass analyses each help provide confidence in the quality of the locomotive FE model.

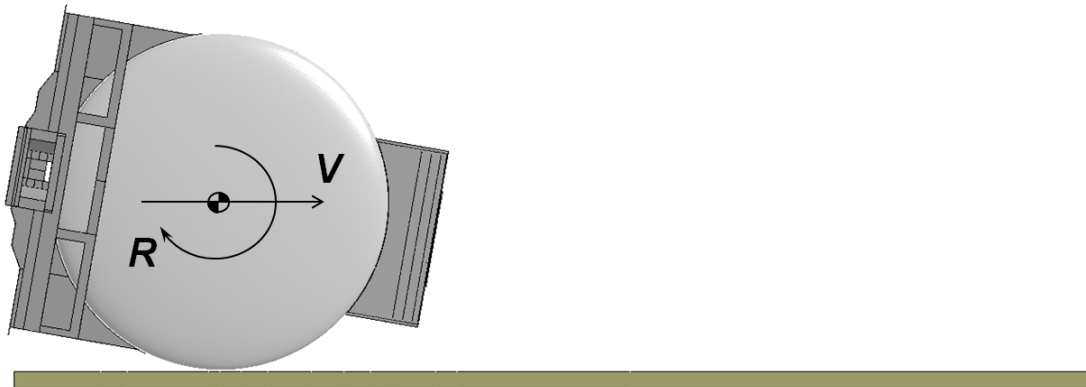
Figure 69. Tractor-trailer rollover collision scenario.

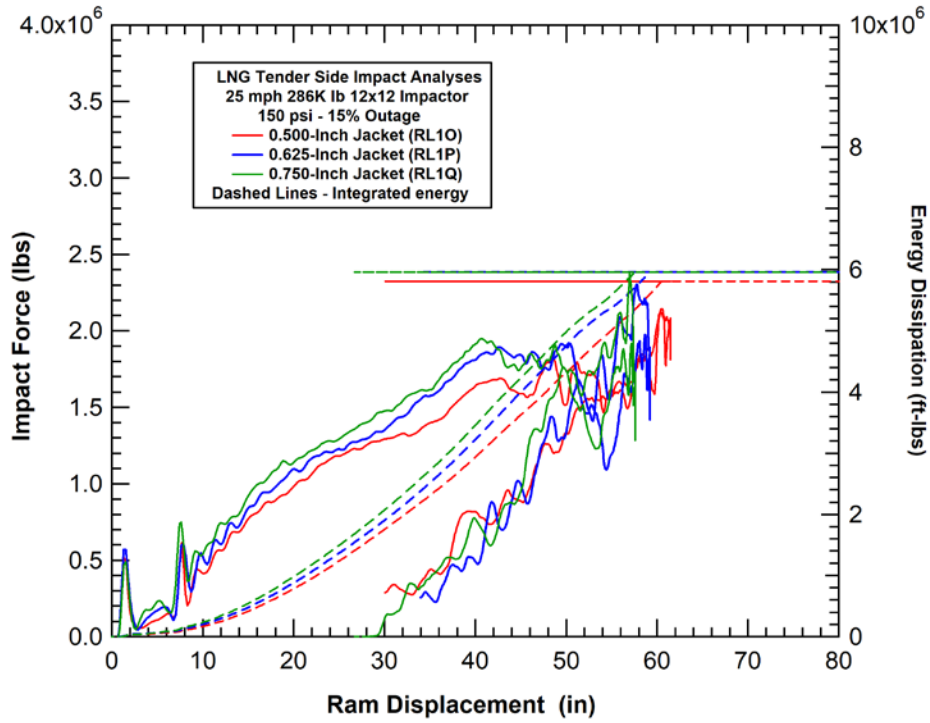
Figure 82. Calculated force-deflection histories for 25 mph impacts and various jacket thicknesses.

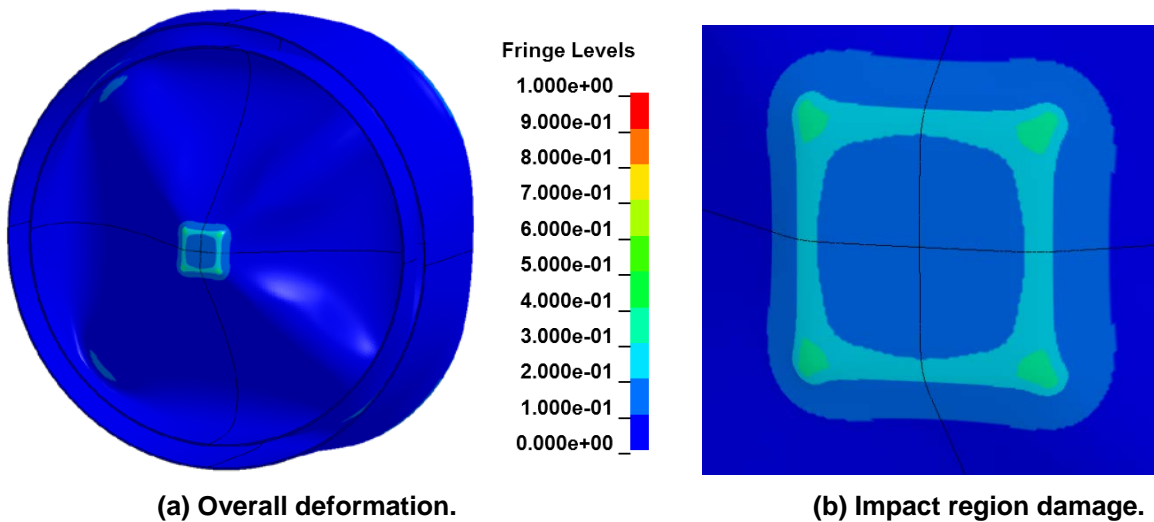
Figure 89. Calculated inner tank head damage for a 30 mph center head impact.

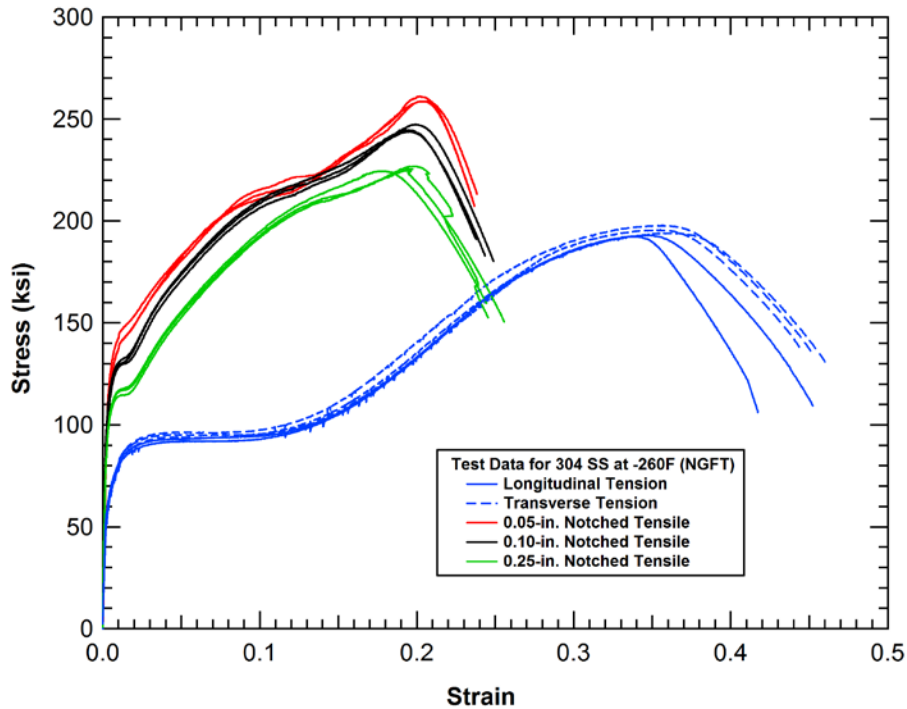
**Figure A3. Summary of the 304 stainless quasistatic tensile test data.**
