# Holden Grate-Lock® Chock Inspection and Repair Standards: Procedure and Examples

(July 2017)

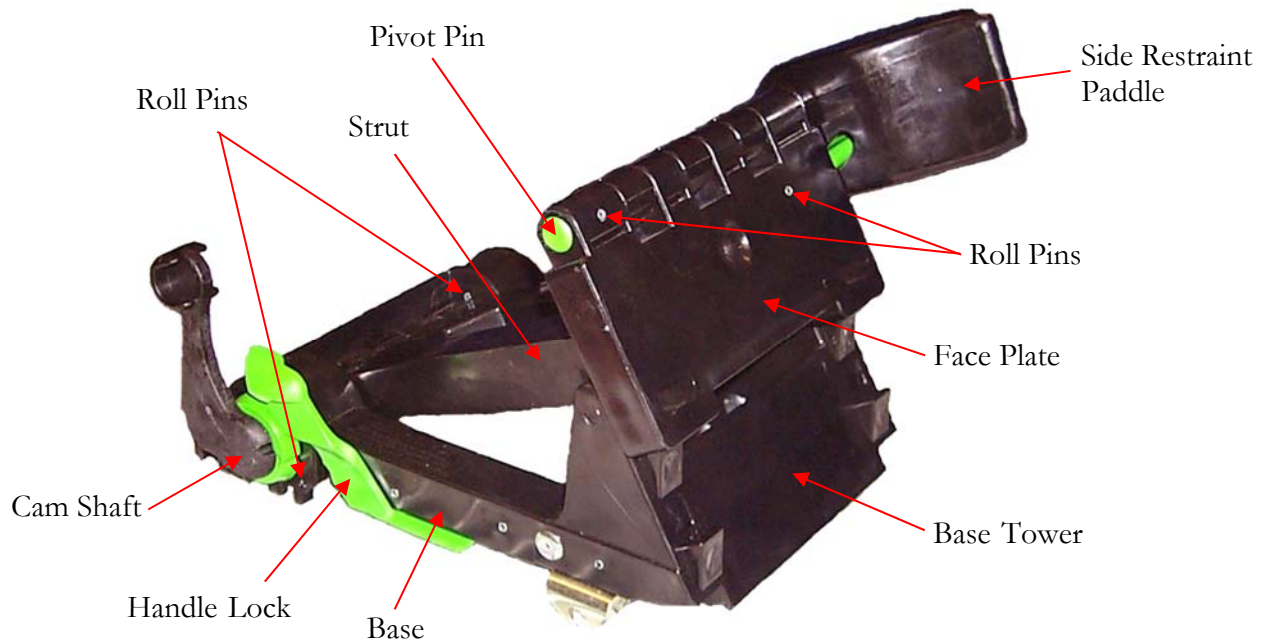
**Figure 1: Upperside Component Nomenclature**

All major plastic chock components, namely the Base, Strut, and Face Plate should be examined for cracks, fractures, and visible deformations like strain whitening marks. (See Figure 1 for component nomenclature). If defects are found, then the chock is considered to be non-functional and must be repaired or replaced as outlined in the following sections.

- d) The Side Restraint Paddle may have minor deformation, or may be cracked where the paddle arm meets the main body of the Strut. (See Figure 1). Although the chock's lateral restraint capability may be compromised, the chock is still considered to be functional, provided the chock can be adjusted normally. The Side Restraint Paddle is considered to be non-functional when found broken or bent beyond a point of being functional for use. If cracks are found in the webbing of the underside of the Strut (see Figure 6), or if Strut is completely broken through with clear separation, the chock is considered to be non-functional and must be replaced and sent for reconditioning.

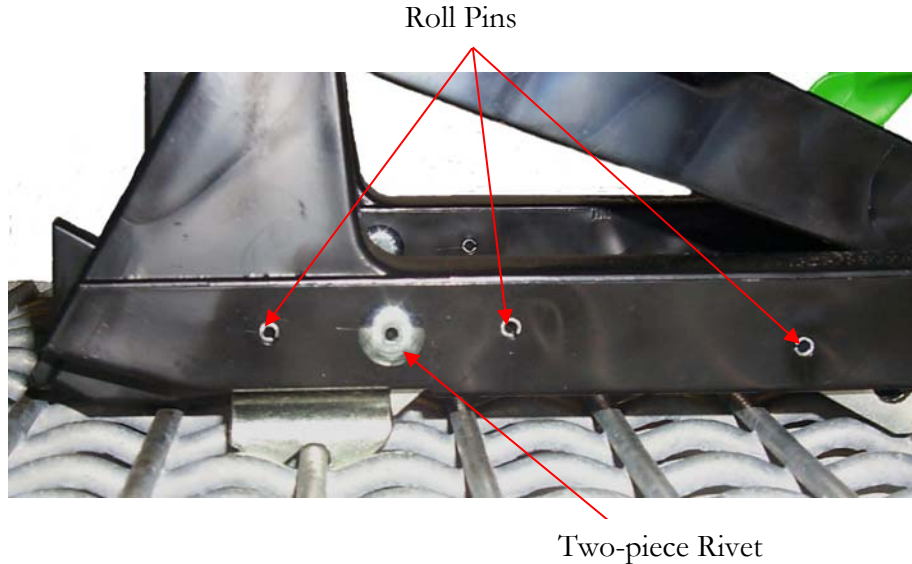
**Figure 5: Side View Component Nomenclature**

- a) The Roll Pins in the Chock Base (12) and in the Face Plate (2) should not be missing or protruding. (See Figures 1 and 5). If any pin is missing, the chock is considered to be non-functional and a new Roll Pin must be replaced in kind. If any pin is protruding by more than

1/8", it must be **lightly** hammered in until flush with Base surface. These repairs can be performed in the field.

Chock Side	Article	Component	Defect Found	Is Chock Functional?	Recommended Repair Decision	Comments
B. Side View Components	a)	Roll Pins	Protruding by more than 1/8" or missing	No	Repair in the Field	Lightly hammer Roll Pin until it is flush with Base. Order OEM Parts.
	b)	Two-piece Rivets	Not tight or missing	No	Repair in the Field	Remove by drilling through rivet. Order OEM Parts.

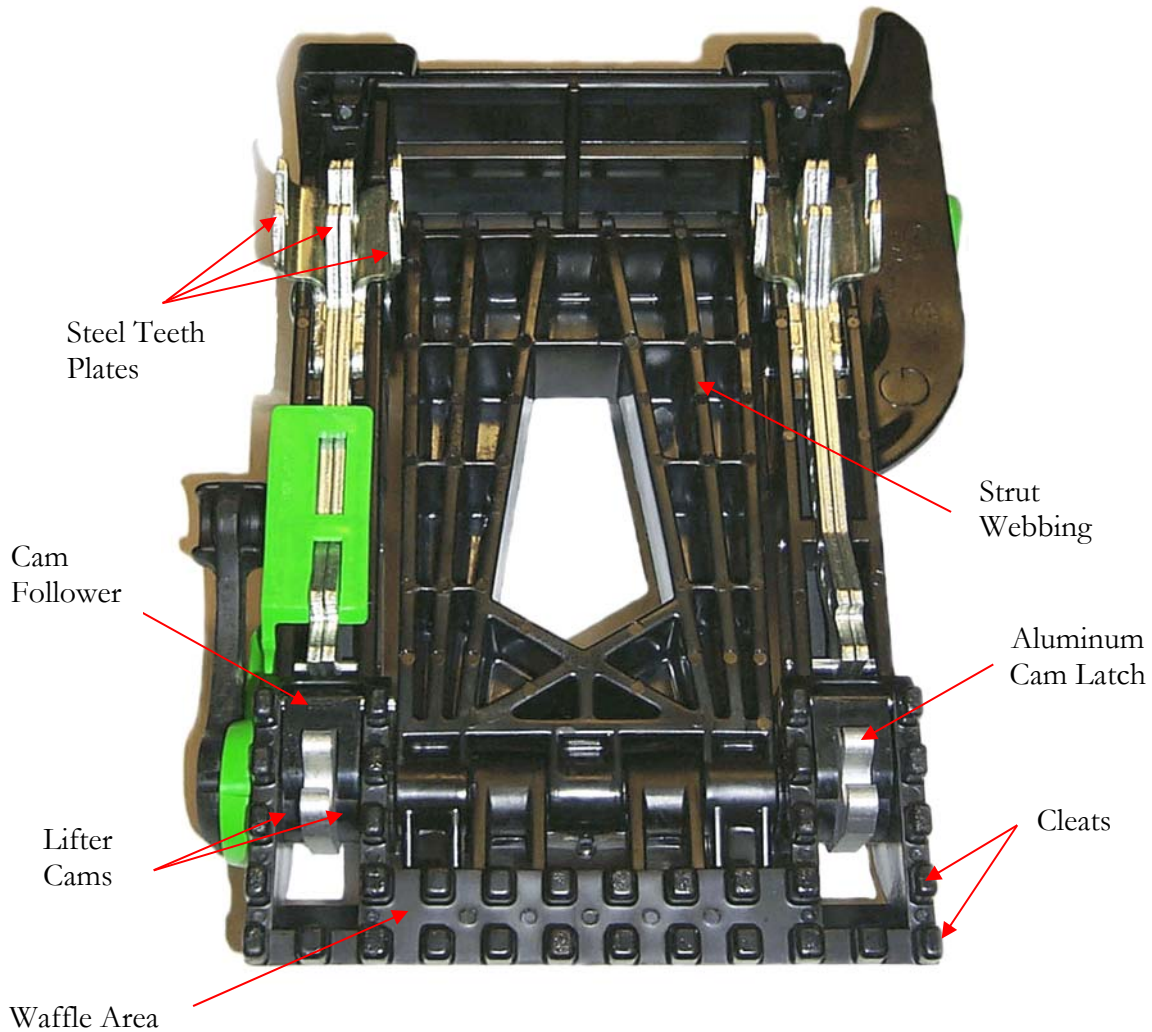
**Figure 6: Underside Component Nomenclature**

All components of the chock should be checked to ensure they are not missing, and have not been deformed or otherwise damaged. (See Figure 6).
