Quality Assurance Auditors & Industry Conference
February 2023 | New Orleans, LA

AAR CSTCC and WABL Committee Updates

Coupling System and Truck Castings Committee

Wheels, Axles, Bearings, and Lubrication Committee Update

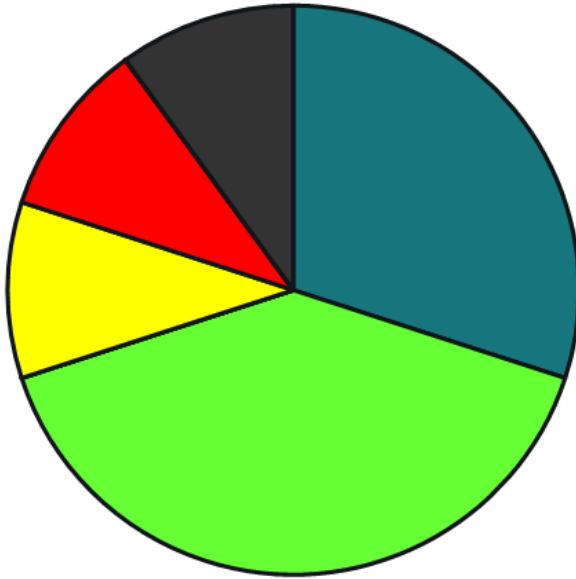
Percent WM 02 (broken) by Location

Note: Simulated data

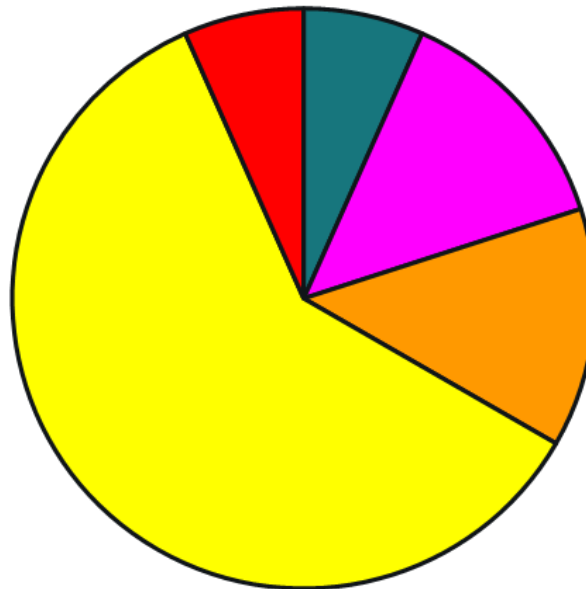
Percent WM 41 (cracked) by Location

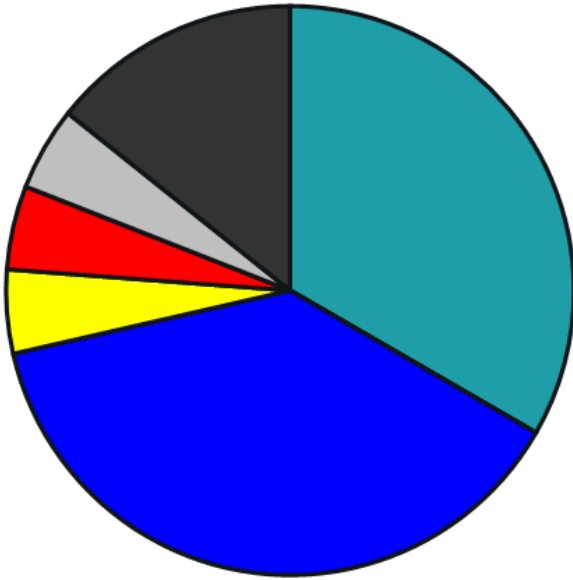
Percent WM 02 (broken) by Location

Note: Simulated data

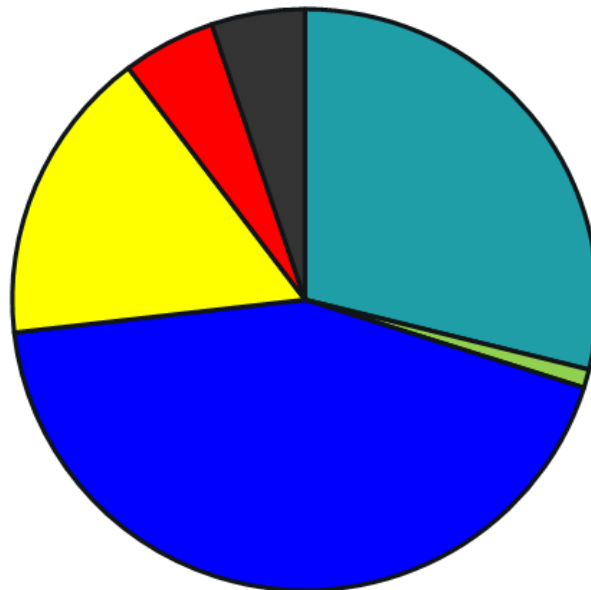
Percent WM 41 (cracked) by Location

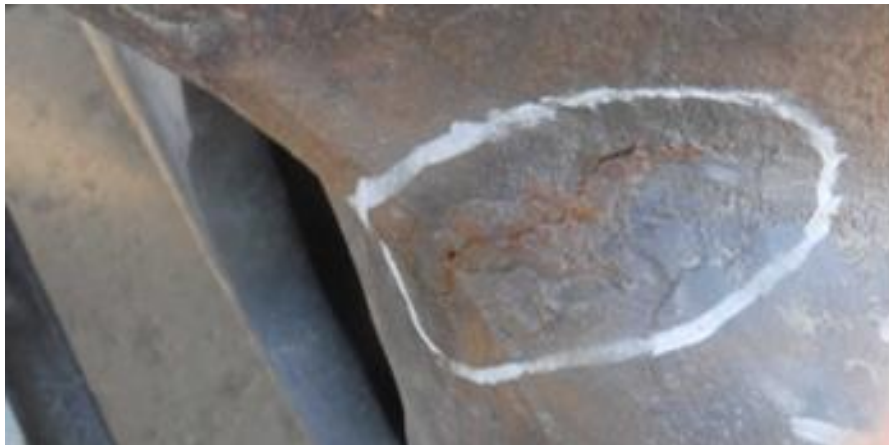
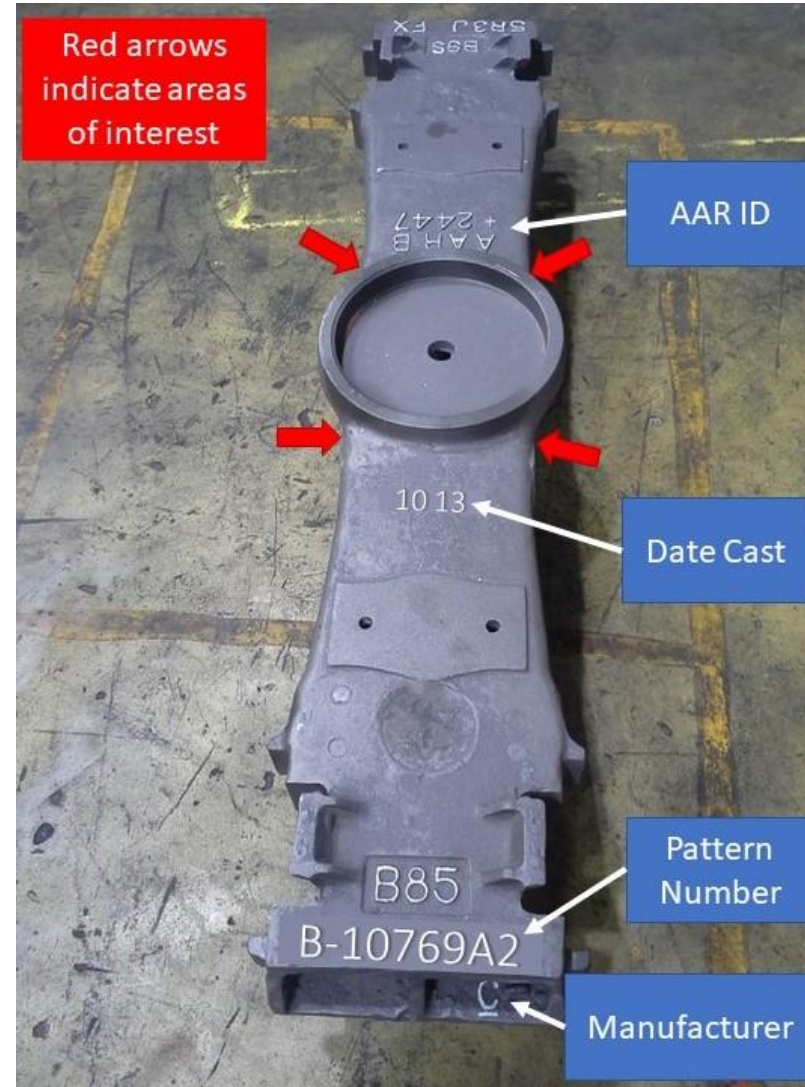
- **Equipment Advisory issued**
 - **EA-0032 CSC Truck Bolsters**
 - Bolsters
 - Cast in 2013
 - Pattern numbers B-10769...
 - AAR ID B+2447

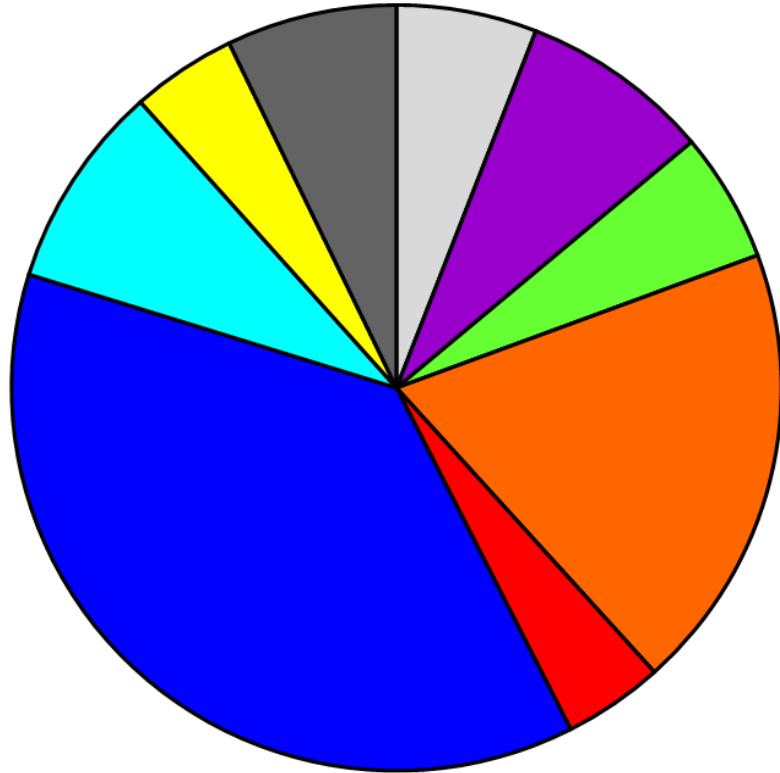
Percent WM 02 (broken) by Location

Note: Simulated data

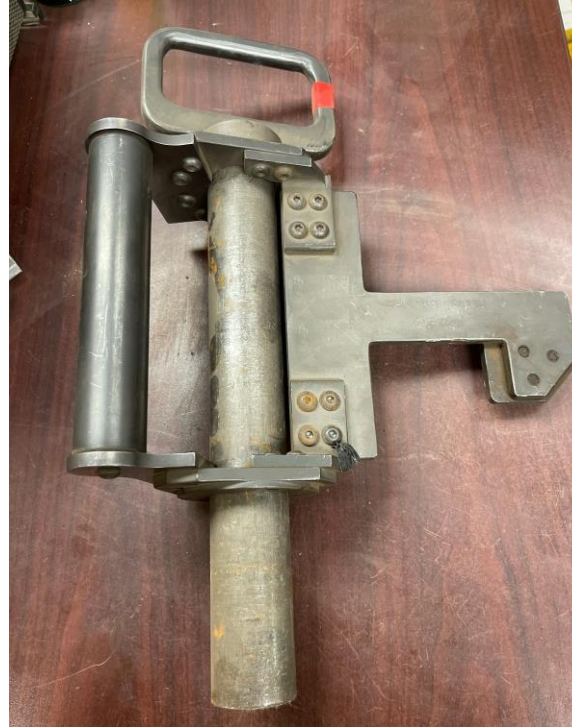
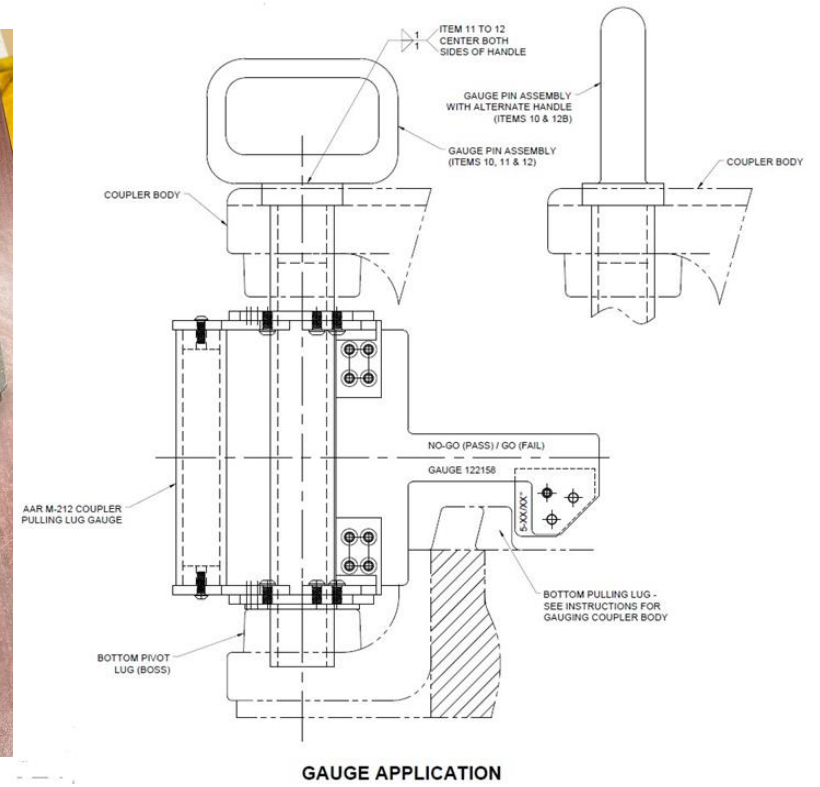
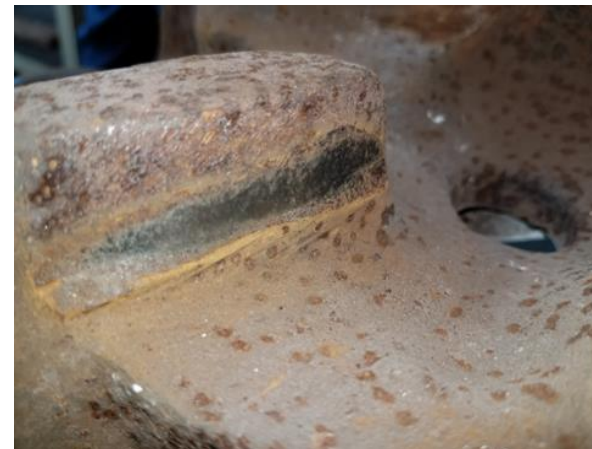
- **Pulling Lug Gauge**
 - Eliminates couplers with overworn pulling lugs
 - M-212 update
 - Circular Letter C-14034
 - Gauge No. 122158
 - Insert No. 122159

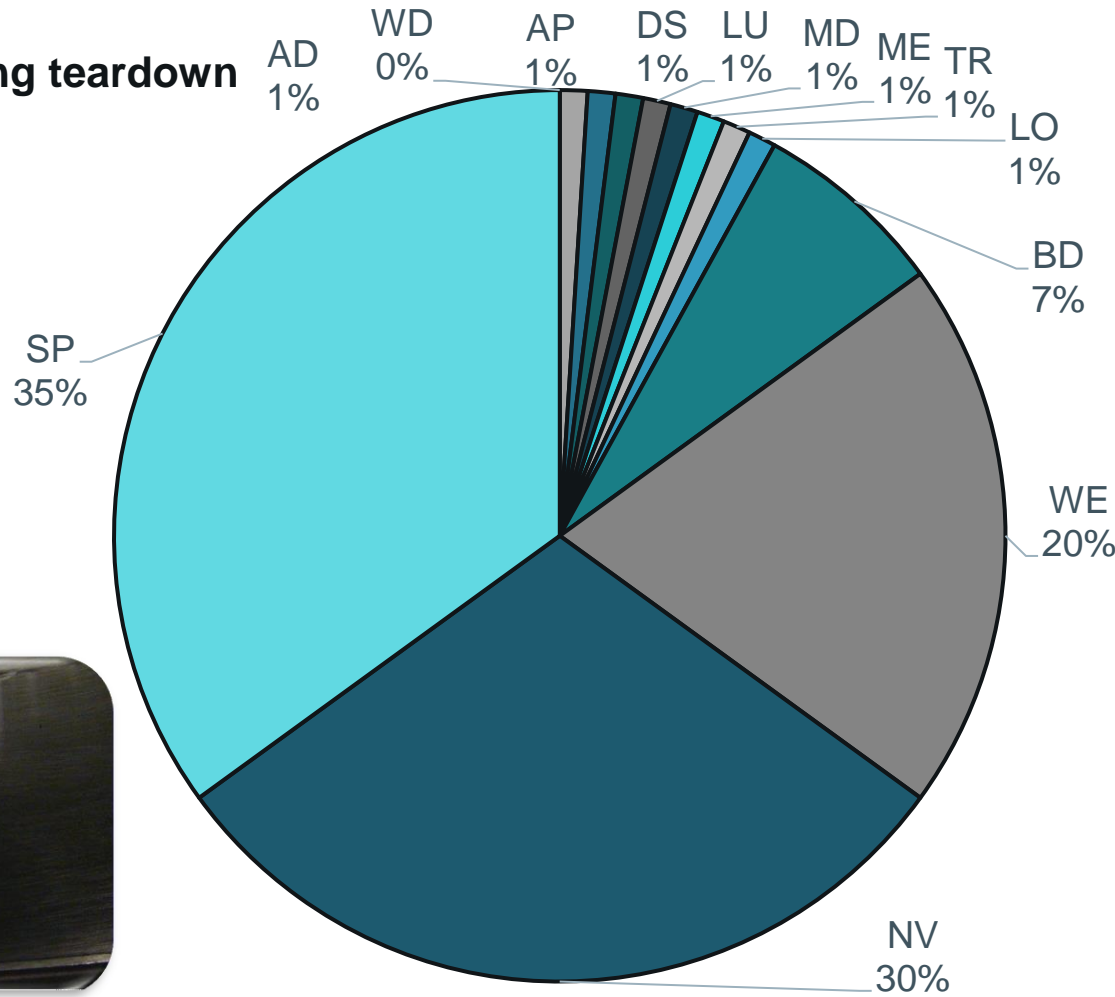
MD-11 – Roller Bearings

- 5 years of bearing teardown data
- ~23,000 records

Failure Progression Mode (FPM)	
AD	Adapter – Displaced, Worn, Wrong Size or Broken
AP	Application Defects
BD	Bearing Destroyed, Undetermined
DS	Displaced Seal
LO	Loose Bearing
LU	Lubrication
MD	Manufacturer/Remanufacturer/Reconditioner Defect
ME	Mechanical
NV	Non Verified Setout
SP	Fatigue Spalling
TR	Truck Related
WD	Wheel Tread Defect
WE	Water Etch

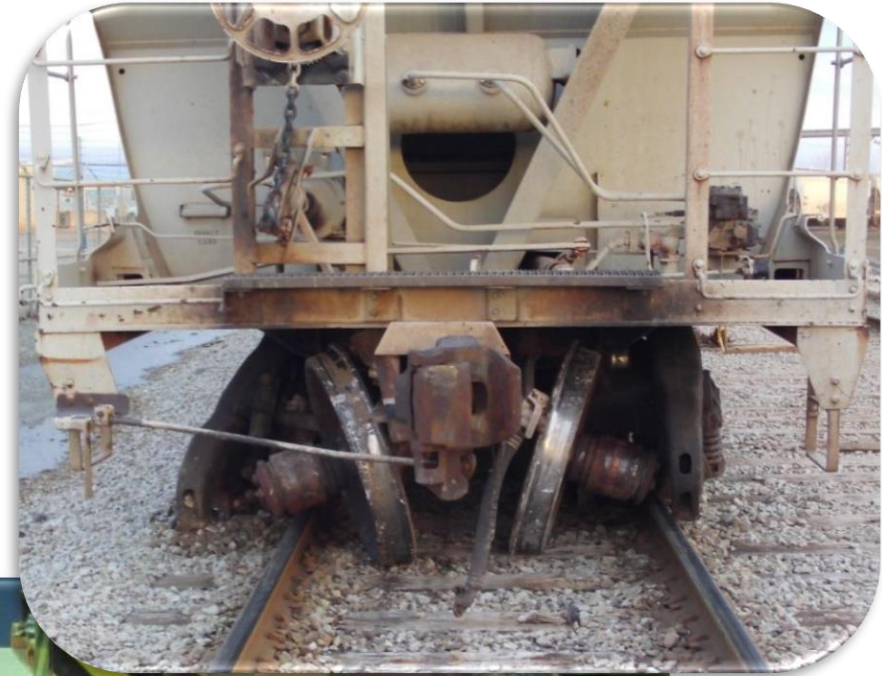
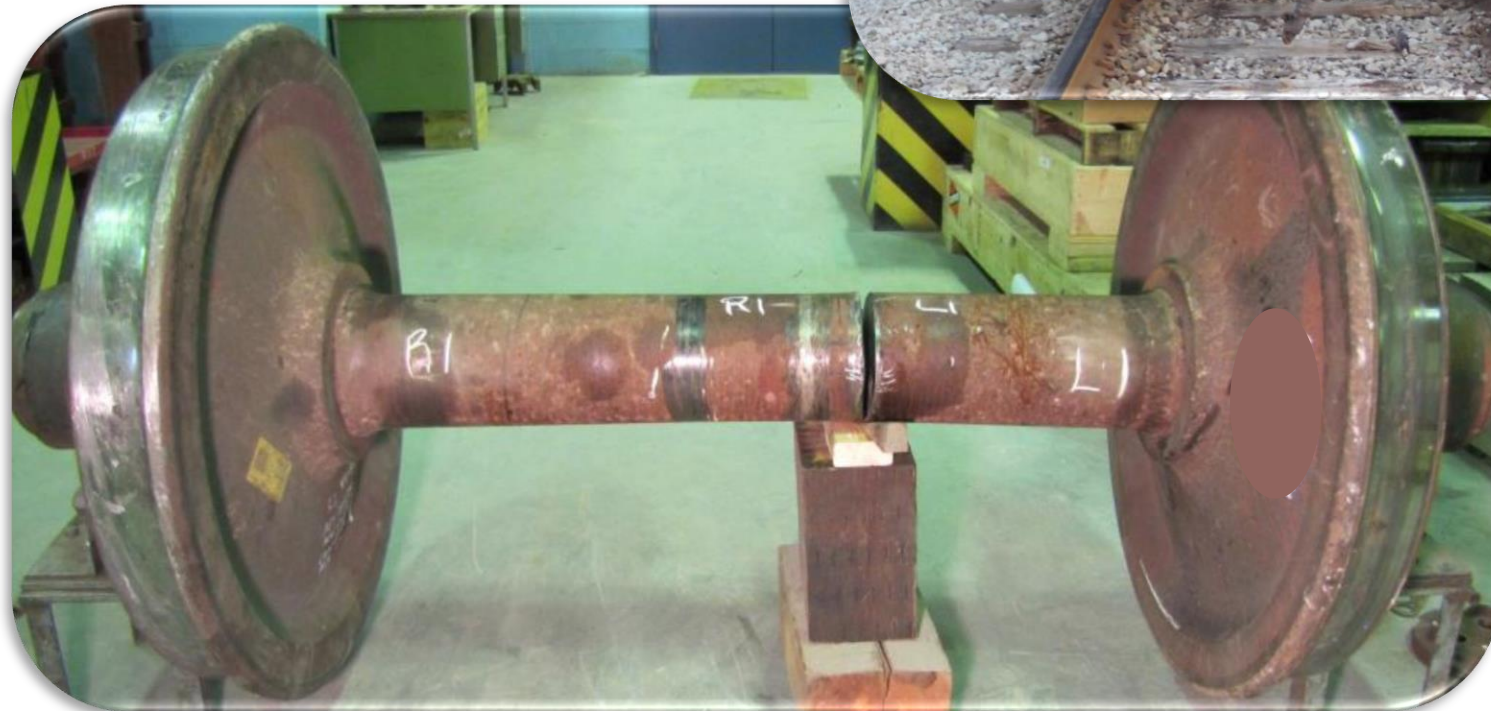
MD-12 - Axles

- 10 reported over the last 4 years
- WABL reviews all reported axles

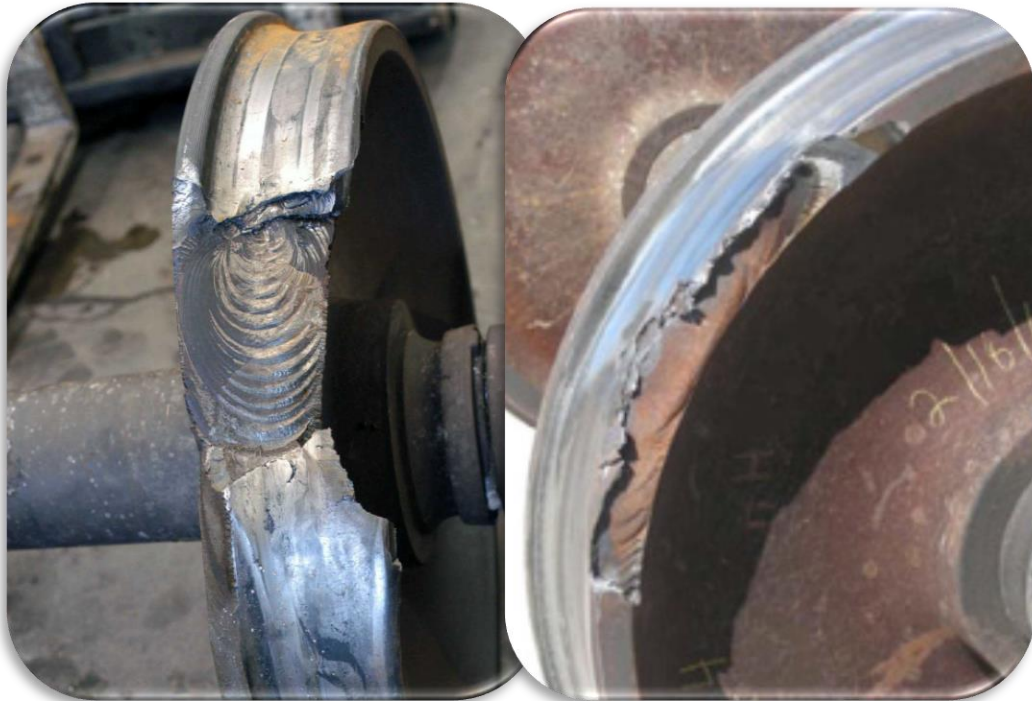
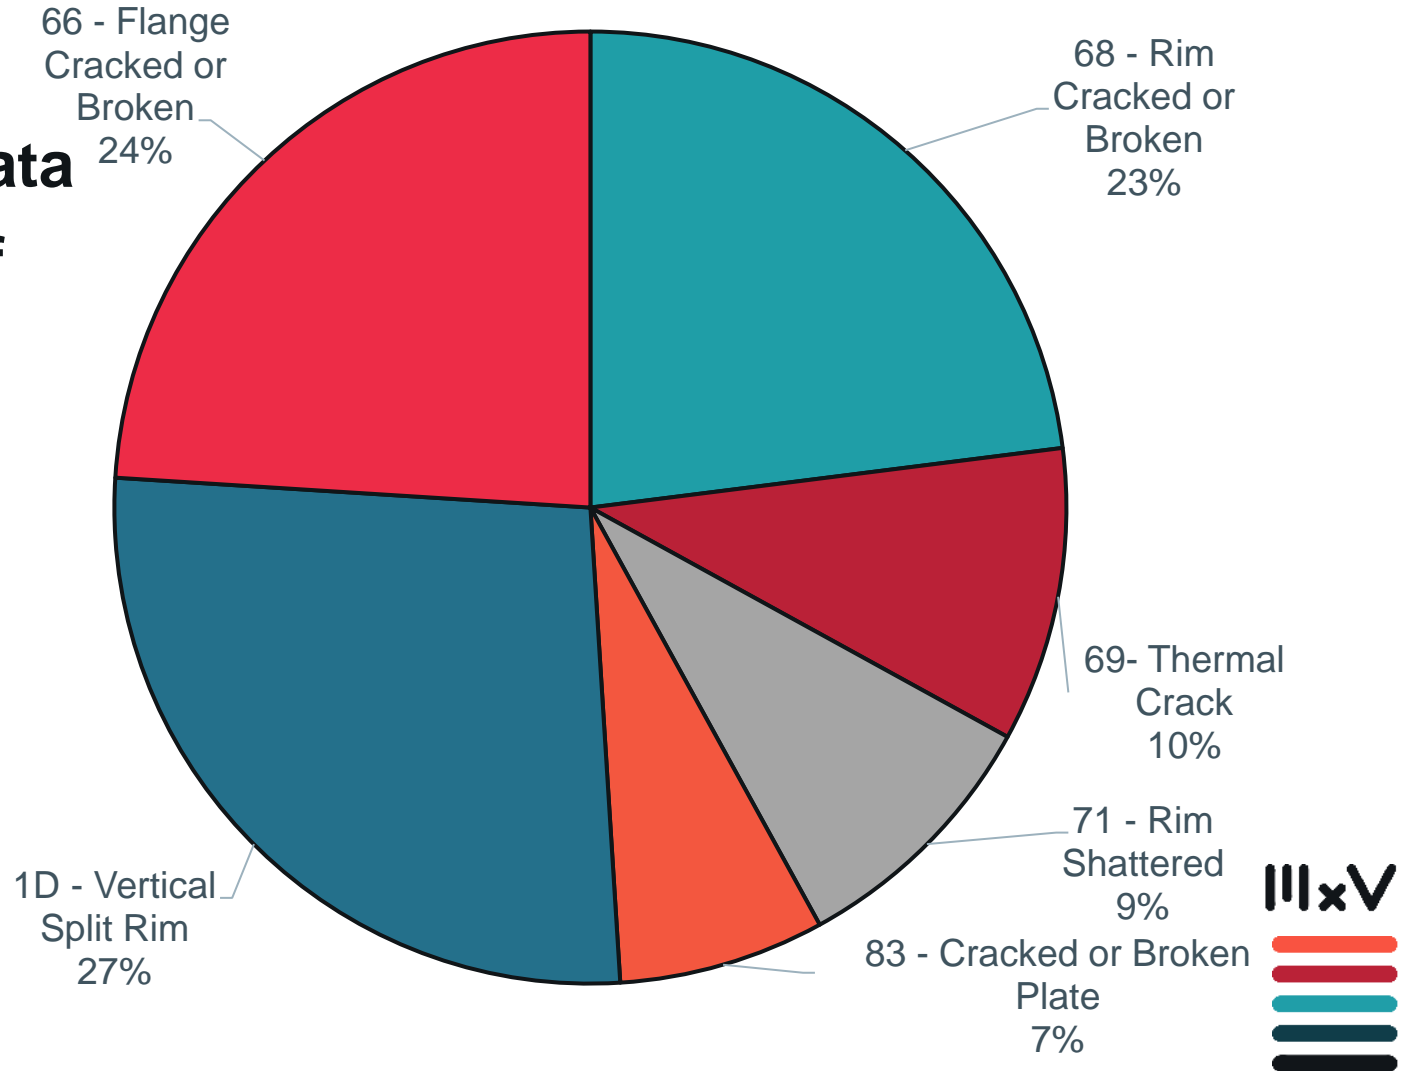
MD-115 - Wheels

- MD-115 and CRB removal data
- Analysis includes 3 years of data
 - ~2,300 records

Note: Simulated data

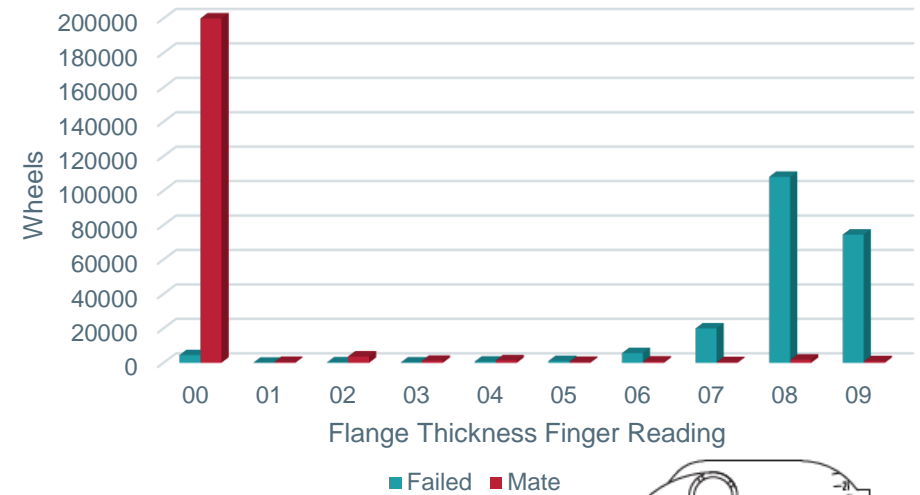
Flange Thickness - Failed vs Mate Wheels

- **TWBL-23.109 Flange Chip**
 - MD-115 Review TAG observed increase of wheels reported WM 66 (cracked or broken flange)
 - Determined cause was due to other wheel defects, primarily WM 60 (thin flange)
 - Updated Rule 41.A.1.d:

d. Cracked or Broken Flange (Why Made Code 66): Any length. Chipped flange must exceed 1 ½ inch in length by ½ inch in width and not merely a flaking of the surface. Do not use WM 66 when wheel meets thin flange WM 60 criteria.
